# COMBATING LEAKS WITH INNOVATIVE MONITORING

Region of Waterloo Completes Pilot Project Incorporating AI Technology

By Stan Fong

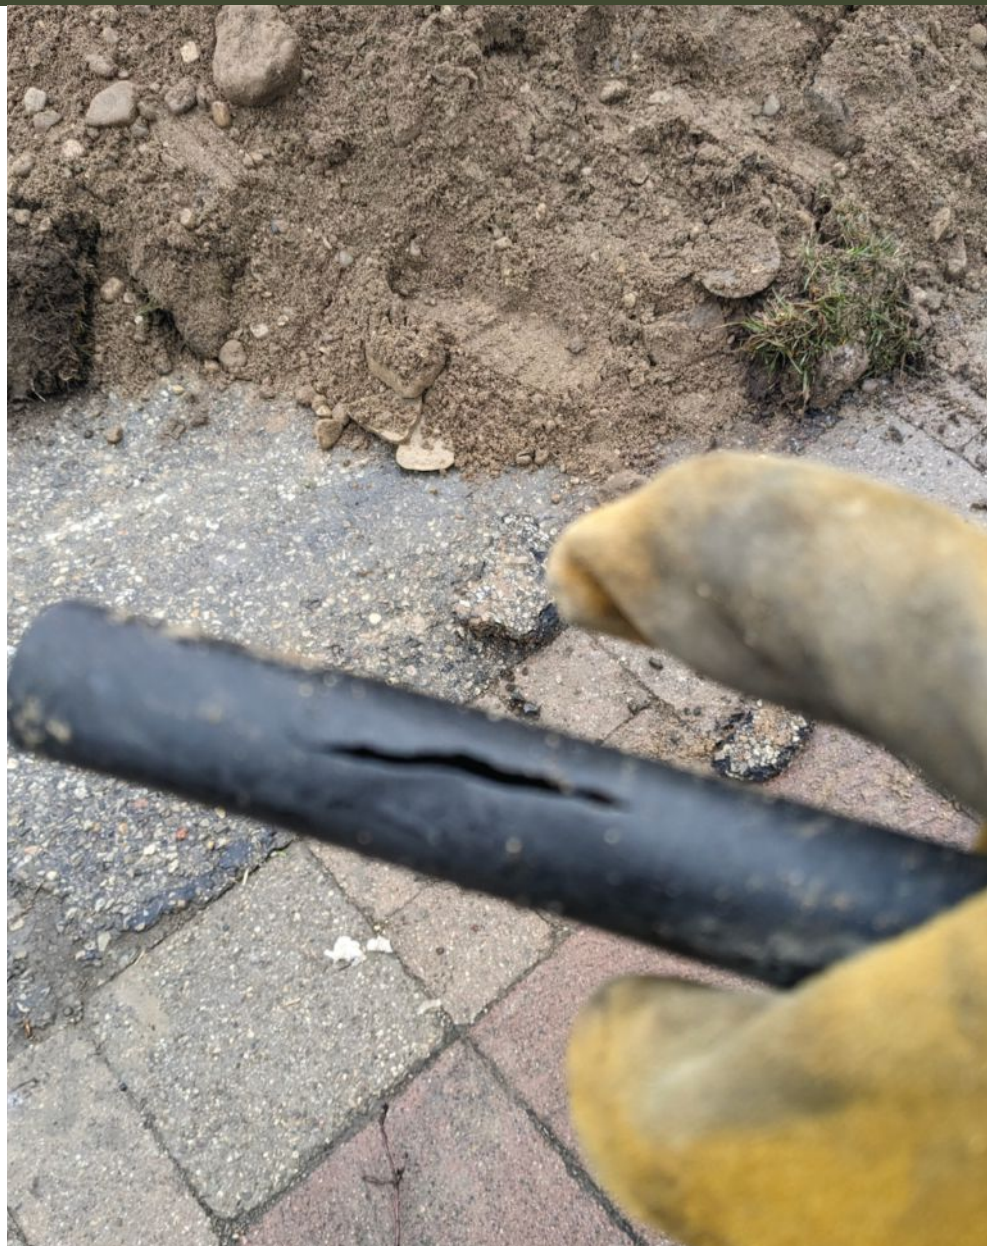
HYD8 – leak geometry a 1.5-in. long crack on a 0.75-in. service connection at time of repair.

The leak was repaired by RMOW on Jan. 17, 2023, after being called in by a resident. The leak geometry/size at the time of repair was an approximately 1.5-in. long crack on a 0.75-in. service connection.

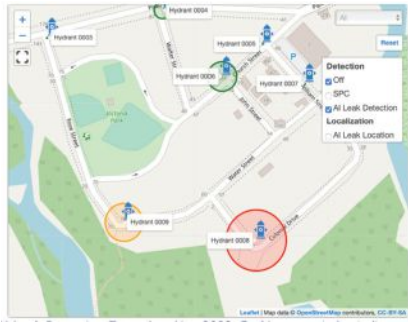
Hydrant.AI Leak Detection  
Example – November 2022. Red/  
orange circles indicate a high  
likelihood leaks.

The first leak (Leak 1) was detected  
on Day 1 of the acoustic AI deploy-  
ment (Nov. 15, 2022) and monitored

The leak was located near HYD8.  
Leak fingerprinting was used to verify  
that the leak had begun prior to the  
start of the pilot. Acoustic noise collect-  
ed by the devices over a 3-week span in  
November, showed no indication of the  
sudden appearance of the leak noise.
