## Leak Detection: Small Leaks – Catching them Early

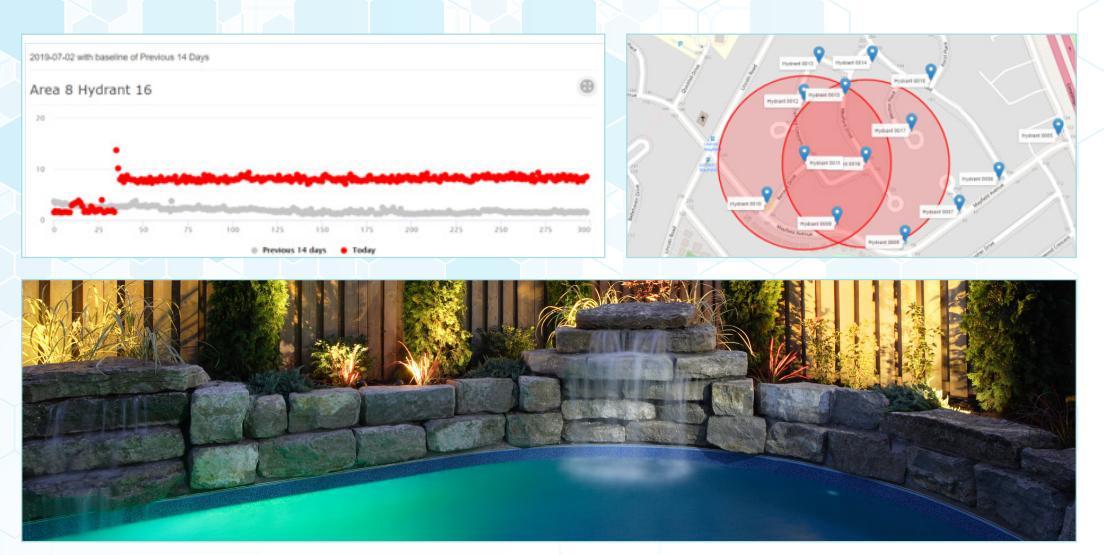
The clear jump and somewhat static acoustic levels detected in the water column are clear indication of an ongoing, relatively consistent flow rate.

At 2:15am the water utility noticed a distinct noise pattern indicating a leak in the area between two hydrants. After investigating the event the utility found that an individual had been filling their swimming pool with a garden hose. The flow rate detected by the units was ~ 5-6gpm. The sensitivity of the units in identifying a leak condition at such a low flow rate provides evidence that the system has the capability to detect small leaks within the distribution system.

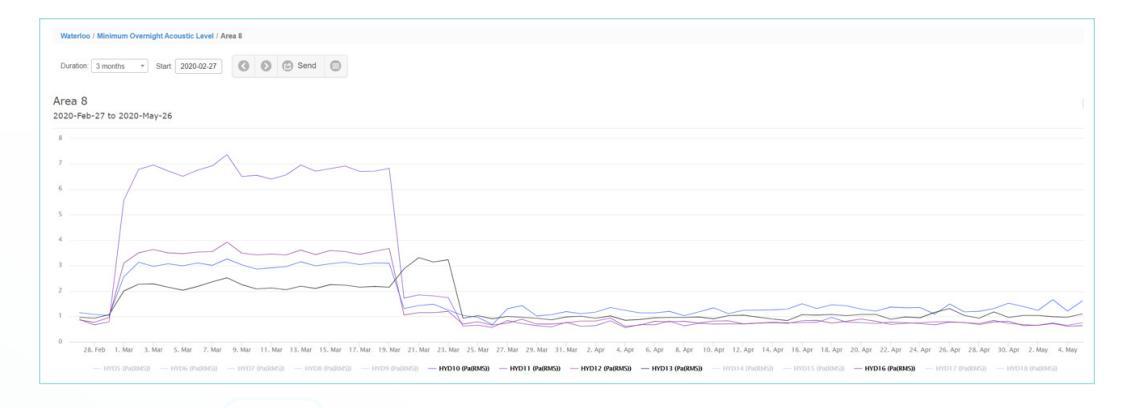
In the same area the water utility noticed a change in the overnight minimum acoustic levels within the system. They quickly identified that a leak had developed and was ongoing.

The leak was found through a leak survey after having been present for almost 3 weeks. The leak was found in the general location identified by the algorithm. When found the crew realized that the leak was going to a storm drain just down the street from where the leak was located.

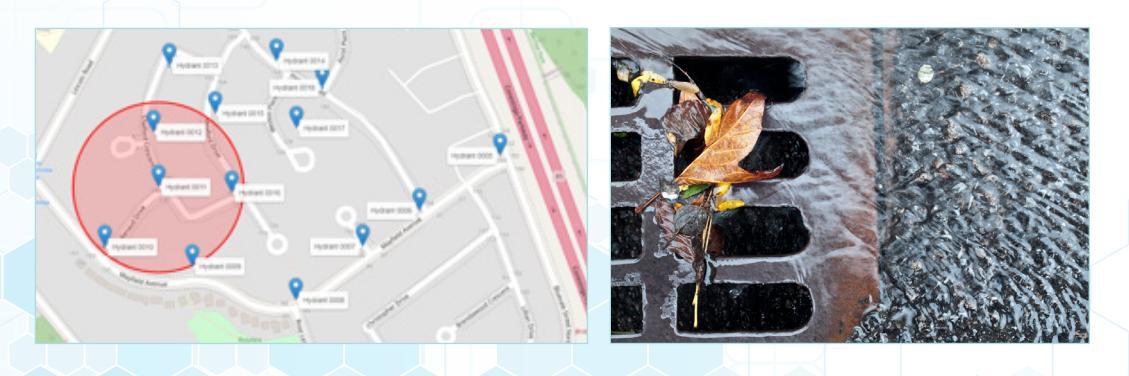
Given the low flow rate associated with the leak and the travel path to the storm drain this leak could have remained undetected for a considerable period of time leading to an increase in non-revenue water and potentially a larger main break in the future.
